**Peer-Reviewed Case Report**

**A Unique Case of Inflow Cannula Obstruction by a Tissue Membrane**

**Roopa A. Rao,\* Kashif Saleem, Bistees George, Maya Guglin**

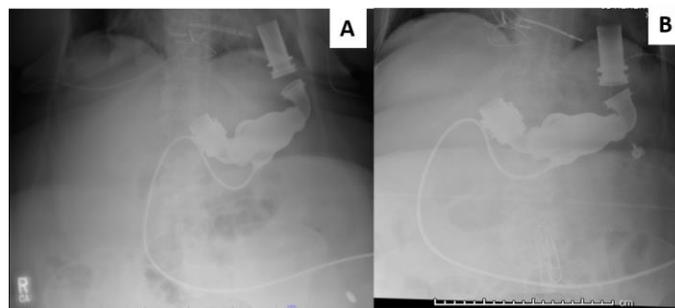
**Figure 2.** A) X-ray obtained following HeartMate II implantation. B) X-ray obtained seven years later showed the inflow cannula's malposition.

pump stoppages. It is known that inflow cannula angulation is a risk factor for pump thrombosis.<sup>4</sup> In our patient, the inlet cannula position had changed over time with angulation towards the septum. This likely occurred because of a significant and intentional weight loss (135 kg to 115 kg) as the patient tried to gain eligibility for cardiac transplantation. Intraoperatively, the inlet cannula had to be forcefully separated from the ventricular septum. It is possible that the septal tissue proximation of the inflow cannula triggered tissue ingrowth. In prosthetic valves, shear stress is also known to contribute to pannus formation.<sup>10</sup> Alteration in the inflow angulation could have caused blood flow turbulence around the inflow cannula and resulted in tissue growth in this case.

The next day, the patient underwent a successful exchange to HeartMate 3 (HM3, Abbott Laboratories). Initially, the heart and LVAD were dissected. Intraoperative transesophageal echocardiogram displayed the cannula directed towards the septum with dense material around it (Figure 3). The inflow cannula had started to core into the septum; thus, it was removed with difficulty. The inflow cannula

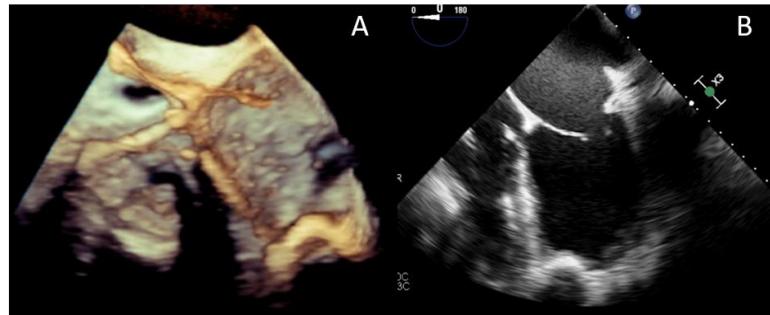
**Figure 3.** *Transesophageal echocardiography images of the inflow cannula in the A) 3D and B) 2D views show the cannula adhered to the septum.*

strongly adhered to the myocardium. The apical cuff for the HMII was used and modified by cut down. The HM3 inflow cannula was placed into the HMII cuff, and a tie band was used. The outflow graft for the HMII was cut about 10 cm from the aorta, and an end-to-end graft anastomosis was done with the HM3 outflow graft. The direction of the cannula was repositioned in two ways. The HMII was housed in the preperitoneal fat. The HM3 was placed intrapericardially, which changed the position of the inflow cannula. Also, a stitch was placed through the Gortex membrane that was placed around the proximal outflow graft and tacked to the caudal portion of the pericardium; this allowed for a change in the angulation of the inflow graft.

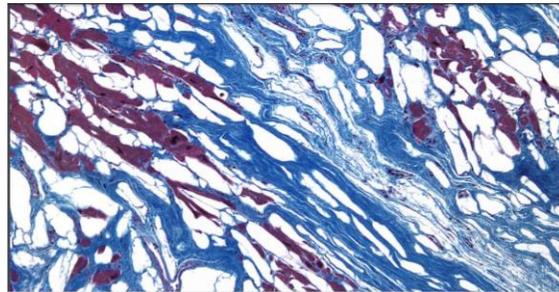
material showed mainly fibrous tissue with myocardial cells and no thrombotic masses (Figure 5). The engineers concluded that this was a plug of pre-existing fibrous and cardiac muscle tissue with only a small amount of fibrin at the perimeter, essentially plugging the inlet tube and impeding the flow.

**Figure 5.** *Histopathology of the membrane shows cardiomyocytes and fibrous tissue.*

To our knowledge, this is the first case reported in the literature. The histopathology showed mature tissue of mainly fibrous material and myocardial cells. A thrombus was not seen. The etiology of such a finding is unclear. However, it is well known that prosthetic valves develop pannus over time, which can impede blood flow and obstruct the valve. Pannus formation is a chronic process usually seen on the ventricular side of the valve. It is thought to be a neointimal proliferation from tissue migration, the proliferation of myofibroblasts, and the extracellular matrix with vascular components.<sup>9</sup> We propose that what we observed in our patient is similar to the tissue growth seen around the inlet of the LVAD. The other possibility is that the inflow cannula could have imbedded into the septum; hence the cannula was stuck and had to be forcefully separated. This could also explain the presence of muscle tissue in histopathology.

Traditionally, pump thrombosis is treated with an intensification of the anticoagulation regimen.<sup>11</sup> In some cases, there are reports of using a fibrinolytic as well.<sup>12</sup> Since the definitive treatment of such tissue overgrowth is only operative, using an antithrombotic or fibrinolytic agent will not have a therapeutic yield.
