## **STRAY CURRENT CORROSION CONTROL EVALUATION**

Various Facilities At The Texas Medical Center  
That Are Impacted By Metro Light Rail Transit Operations  
Houston, Texas

Prepared By: **CORRPRO COMPANIES, INC.**  
7000B Hollister Road  
Houston, Texas 77040  
(713)460-6000  
[www.Corrpro.com](http://www.Corrpro.com)

July 6, 2007

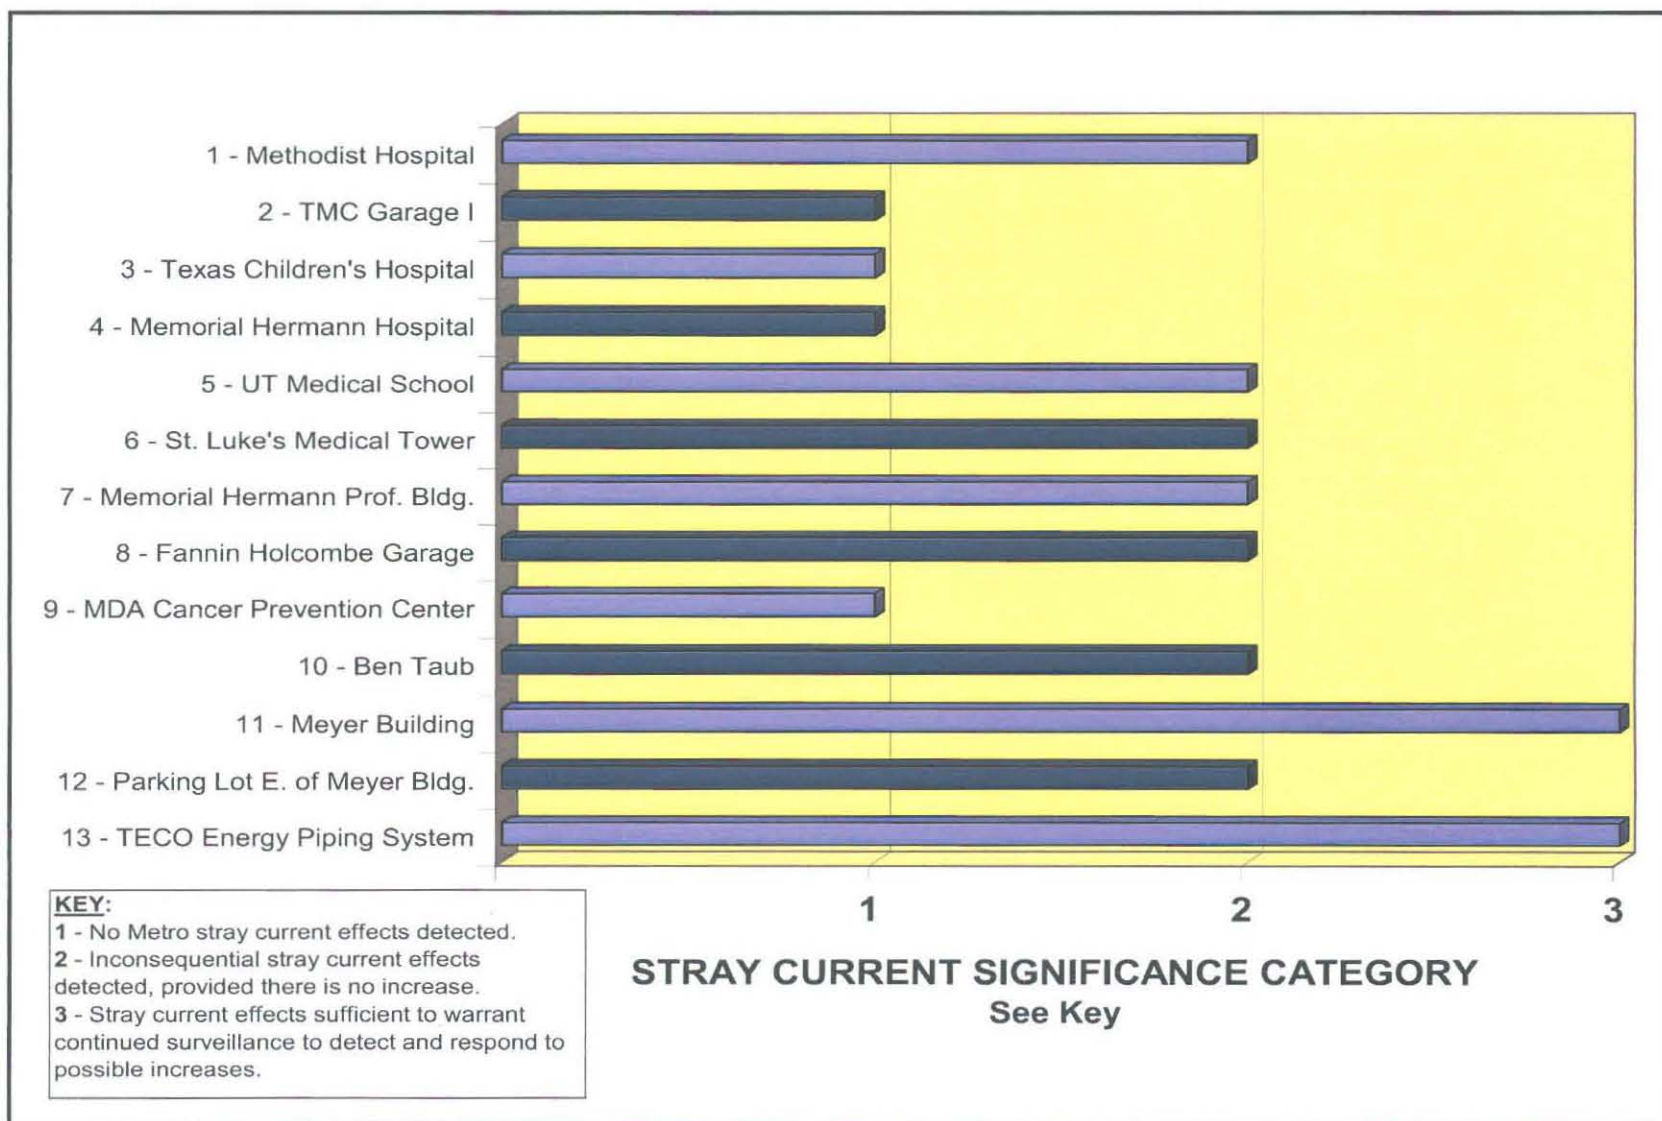
**FIGURE ES-1 - Stray Current Corrosion Control Significance Summary**

Corpro's evaluation primarily addressed exterior (perimeter) steel reinforced concrete basement walls within many of the TMC institutions and incoming, underground metallic utility piping. The evaluation detected Metro caused stray current electrical effects on various TMC facilities. The significance of the stray current is not evenly distributed throughout the TMC and varies from facility to facility and structure to structure. The bar chart in Figure ES-1 presents the composite ranking (category) for each TMC facility evaluated,

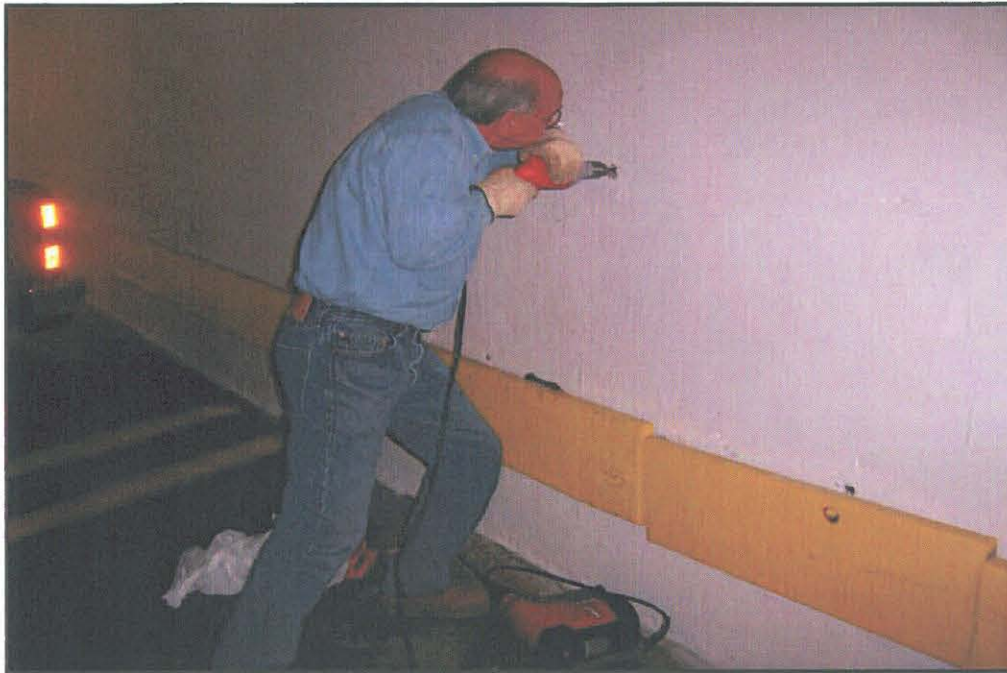
- Exterior (perimeter) wall reinforcing bars, made by electrical test connections to the reinforcing bars through drilled holes on the interior face of the wall (Figure 1a).
- Building interior electrical ground connections.
- Buried sections of the TECO energy piping system, using existing cathodic protection monitoring points.
- Incoming water and natural gas utility piping, at the points of connection to various buildings.
- Exterior electrical ground connections, e.g. electrical grounds for light standards.

a) Drilling Hole Through Concrete To Drill/Tab Test Connection Into Reinforcing Bar

**FIGURE 1 - Typical Structural Steel Test Point**  
Inside Face of Exterior Building Wall

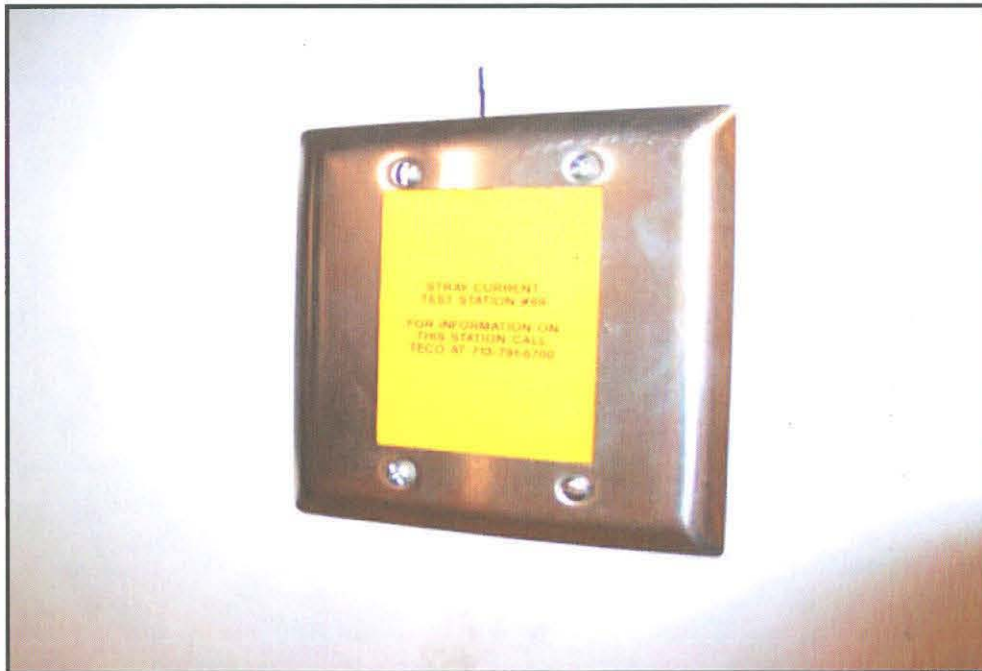
TECO has completed the installation of wall plates and test point identification labels for the electrical test connections. The photograph in Figure 1b illustrates a typical location.

b) TECO-Installed Wall Plate Over Test Connection

- f. Maintaining the 84 structural steel stray current test points established during Corpro's evaluation. The test point cover plates and identification labels installed by TECO and as shown in Figure 1b are adequate for this purpose.

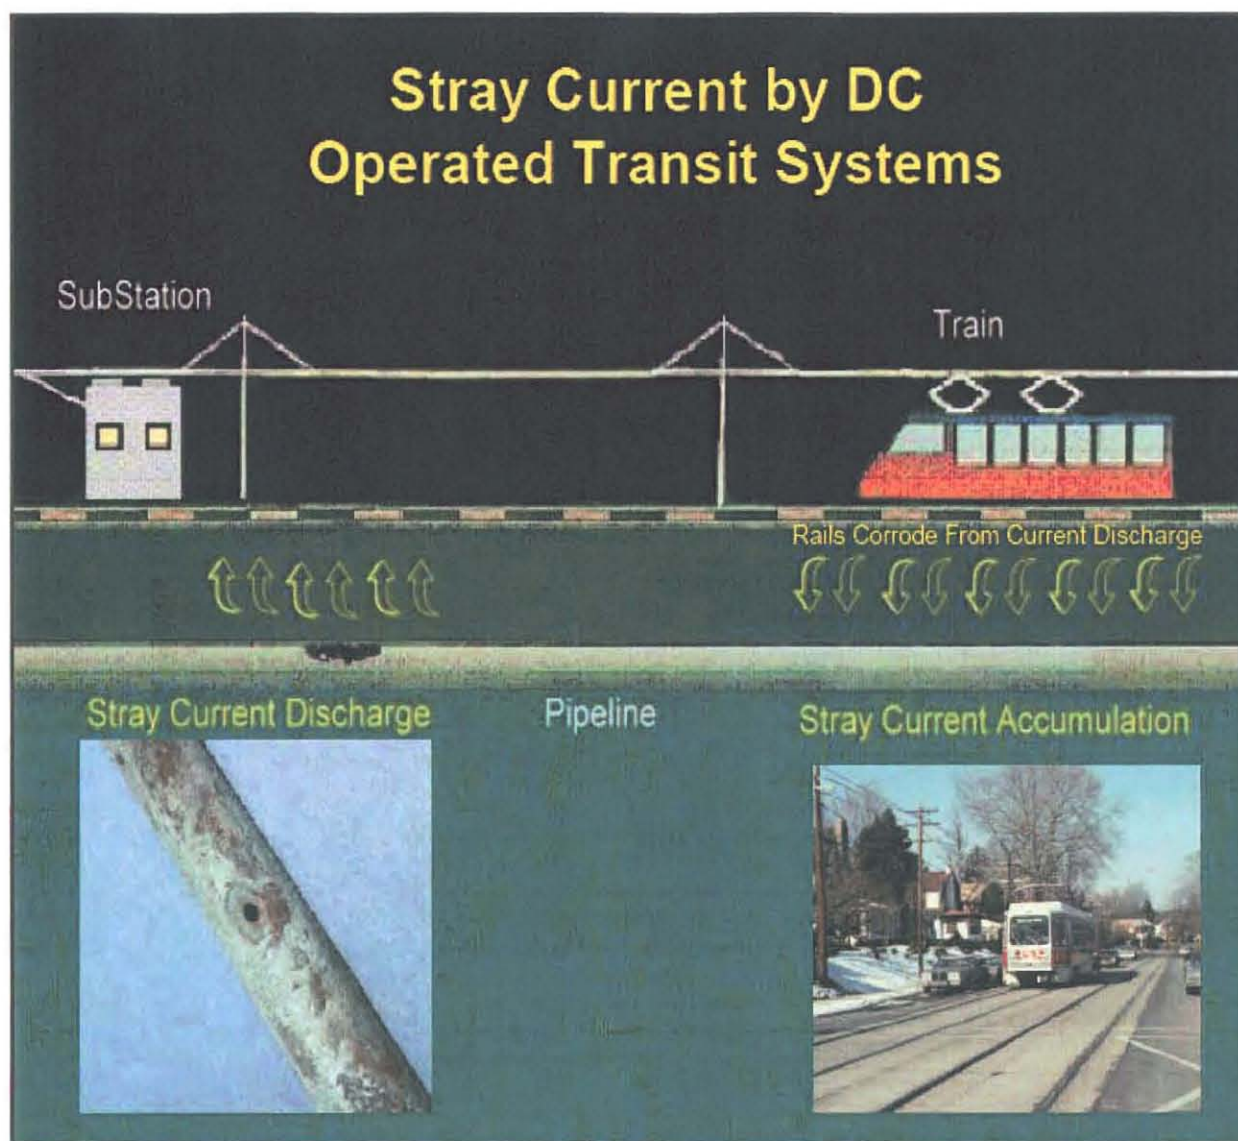
**FIGURE 2 – Stray Current Leakage From DC Operated Transit Systems**

Figure 2 presents a basic illustration of the electric current flow associated with a DC rail system. Stray current entering into the earth from the rails will result in corrosion deterioration of the rails. This is illustrated in the right-hand portion of Figure 2 where the transit vehicle is accelerating at some distance from the traction power substation supplying the electrical current. If the stray current leaking from the rails accumulates onto an underground metallic structure through an earth path, naturally occurring corrosion rates for that structure may be reduced to some degree, i.e. the stray current may provide for some level of cathodic protection. When stray current discharges from the structure to ground through an earth path (left-hand portion of Figure 2), corrosion rates will increase. The increase in corrosion rates is directly related to the magnitude and time duration of the stray current discharge into the ground and inversely related to the surface area over which the stray current is distributed. The corrosion deterioration that can be caused by the stray current discharge is illustrated by the data in Figure 3.

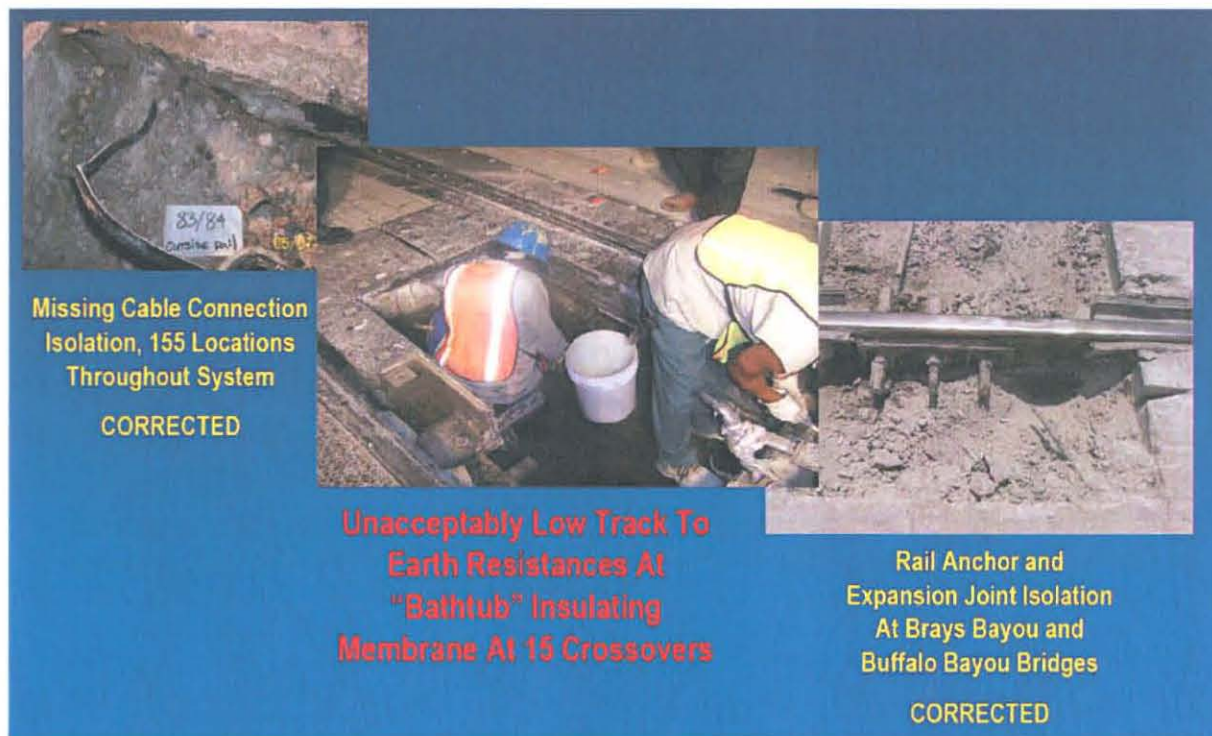
**FIGURE 4 – Corrosion Control Construction Deficiencies Detected By Metro**

Not uncommon for today's light rail systems, the design of the Houston Metro included various provisions to limit stray currents emanating from the transit operations. Most significantly, measures intended to increase the track to earth electrical isolation (resistance) were designed. This included an electrically high resistant "boot" for standard embedded rail and an insulating membrane arrangement ("bathtub") at switches and crossovers. Unfortunately, because of various factors, the minimum track to earth resistance design criteria of 250 ohms per thousand feet of track was not achieved for portions of the Metro track-way before light rail service opened to the public on January 1, 2004. This included much of the approximate 1.8 mile long section of rail line through the TMC complex. Photographs of some of the problematic construction deficiencies detected by Metro are presented in Figure 4.

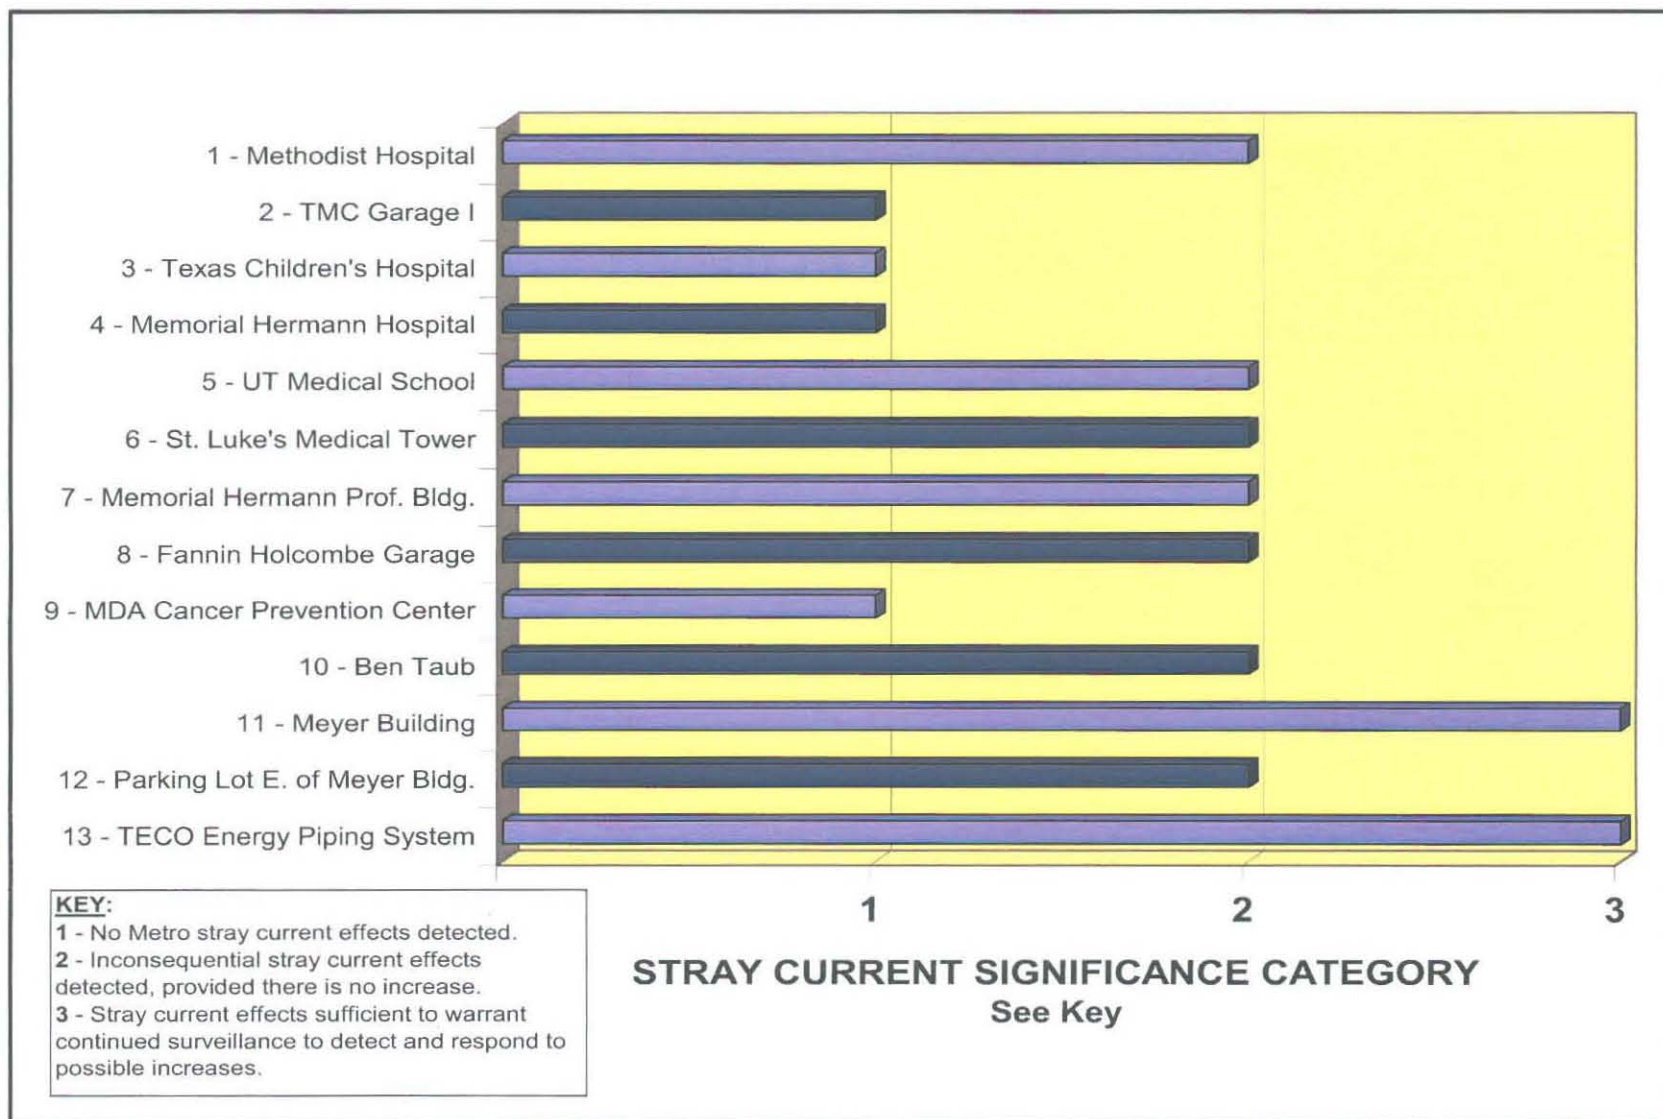
**FIGURE 5 - Stray Current Corrosion Control Significance Summary**

- Category "1" – Non-existent, i.e. no Metro caused stray current effects detected.
- Category "2" – Metro caused stray current effects detected but of sufficiently low magnitude to represent no long term corrosion consequence, provided there is no increase.
- Category "3" – Magnitude of Metro caused stray current effects in the range where continued surveillance is appropriate to respond to possible increases over time.

The bar chart in Figure 5 presents the composite ranking (category) for each TMC facility evaluated, based on data from various structures and test points within that facility.

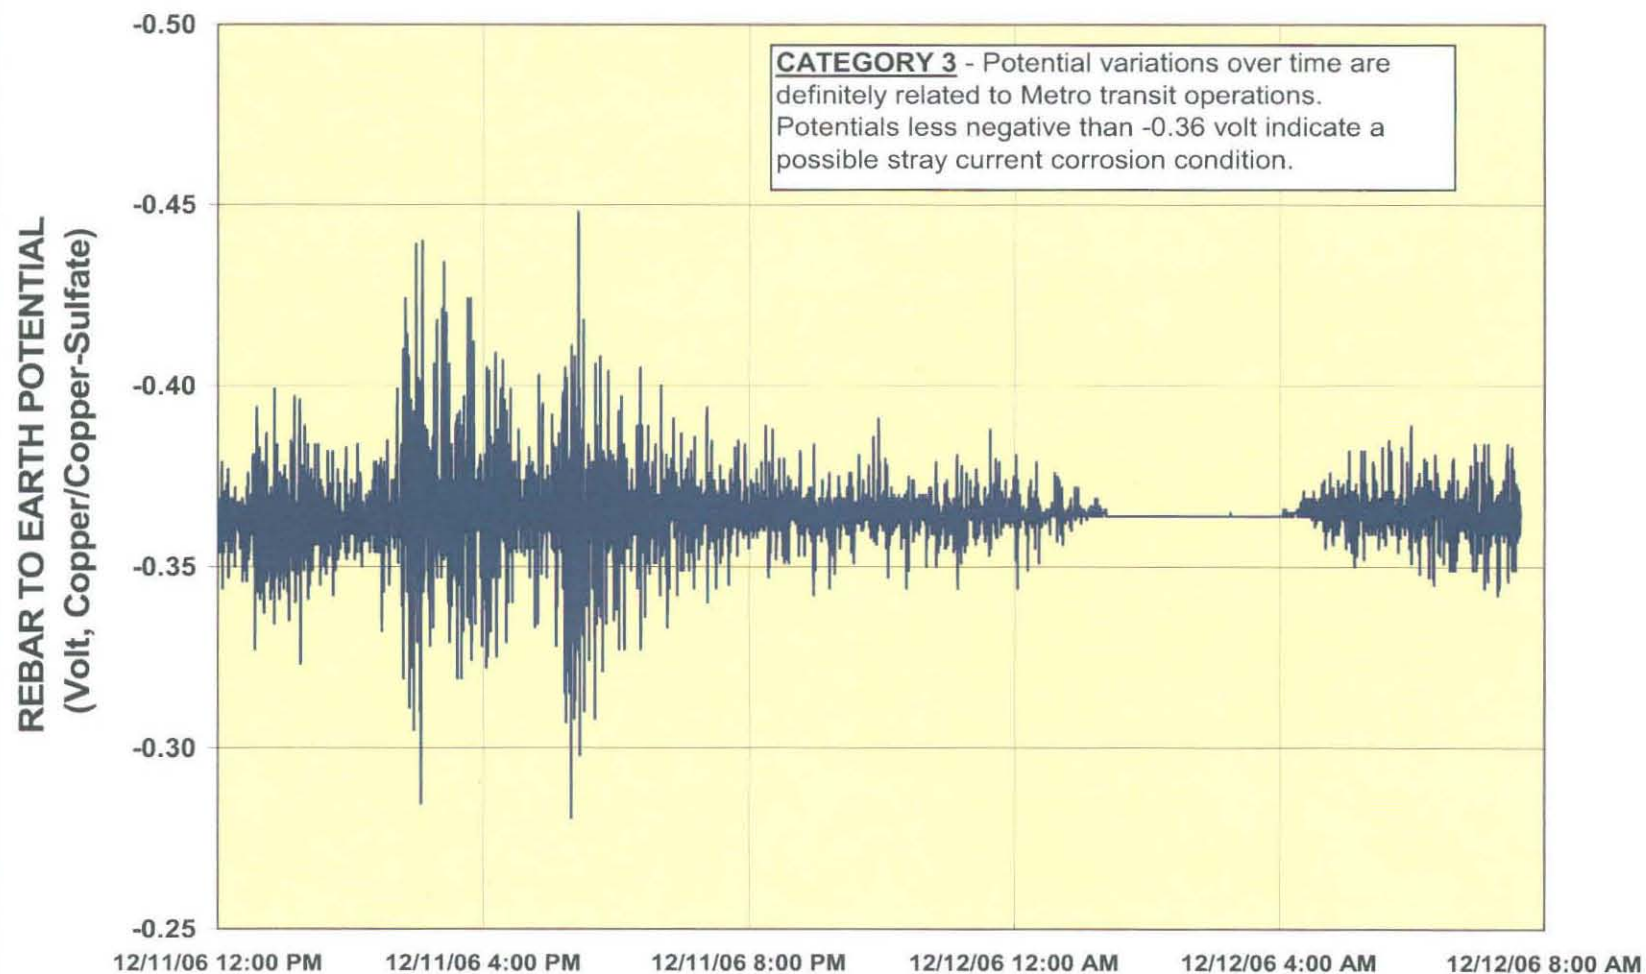
FIGURE 6 – Sample Stray Current Data, Significance Category 3

Figure 6 shows a sample data-logger recording. Referencing this figure as an example, the variations over time of the reinforcing bar to earth voltage are definitely caused by Metro generated stray currents. There is good agreement between when Metro does not operate the light rail line during the early morning hours and the lack of time varying reinforcing bar voltages during this same period. The magnitudes of the voltage variations at this particular location and time do not suggest a structural/corrosion problem requiring immediate remediation. However, like other TMC test locations, they are of sufficient magnitude to establish the basic need for implementing a stray current surveillance program to detect any changes over time that could influence long-term facility reliability and mission critical operations at TMC.

## MEYER BUILDING EXTERIOR WALL REINFORCING
