Peer-Reviewed Case Report

A Case of HeartMate 3 Outflow Graft Twisting with Extraluminal Thrombosis: Is Computed Tomography Angiography Helpful?

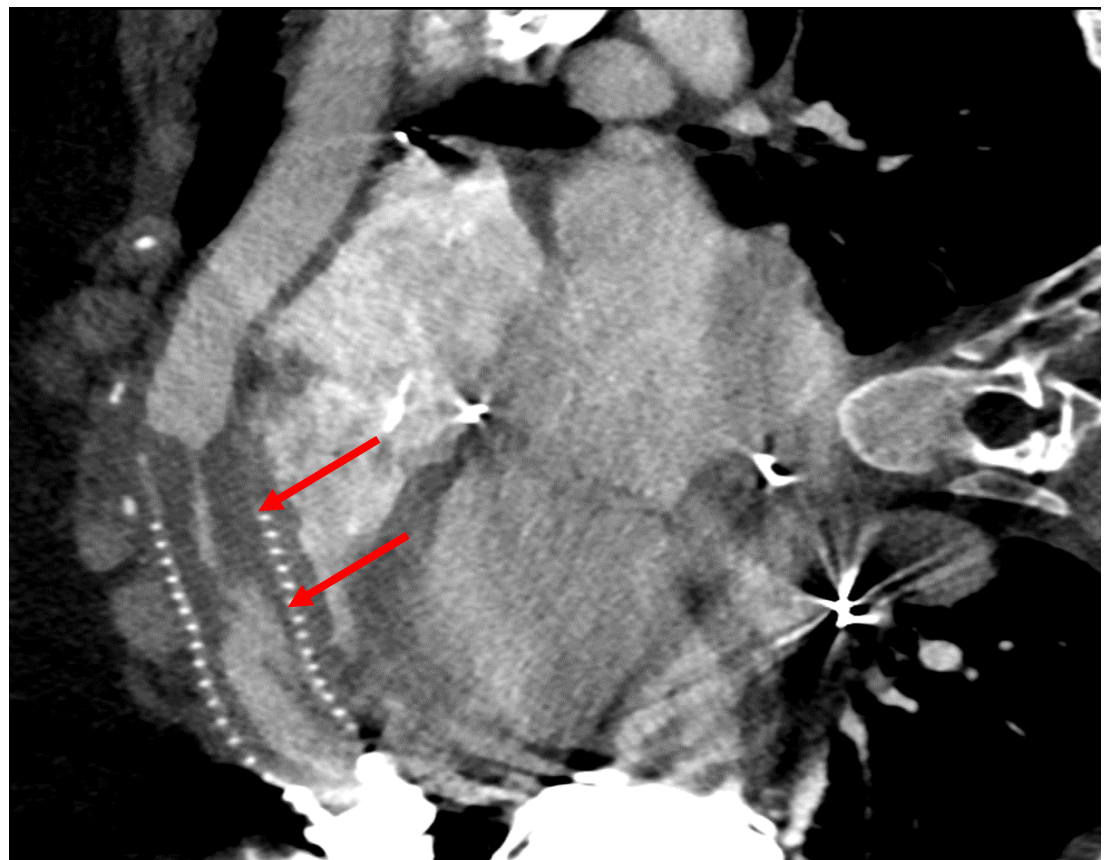
Figure 1A

A 55-year-old female with a past medical history of post-partum cardiomyopathy underwent left ventricular assistive device (LVAD) implantation with HeartMate™ 3 (Abbott). She presented nine months later to the hospital because her LVAD had been logging in persistent low flow alarms, as low as 3.5 L/min (previously 4.8 L/min). She was asymptomatic at that time. Her serum lactate dehydrogenase was mildly elevated at 300 U/L (reference range: 116-250 U/L). Plasma free hemoglobin and total bilirubin were within normal limits. Her international normalized ratio (INR) was found to be 2.8 (target: 1.8-2.2). The INR levels prior to her hospitalization were within the target range. She underwent a gated CT angiography (CTA) chest (arterial phase) examination, which showed low density material at the junction of the bend relief and the rigid portion of the outflow cannula. There was also significant flow obstruction, with imaging characteristics of thrombosis (Fig.1A-C). Of note, no thrombus within the remainder of the outflow cannula was evident.

Figure 1. *Multiplanar reformatted CTA images show the LVAD outflow graft. At the junction of the relief bend and the rigid portion of the outflow limb, an eccentric low attenuation density material (arrows) is present, with severe narrowing of the flow stream.*

The patient was taken for surgical exploration of her LVAD system via a subxiphoid approach. Intraoperatively, an epiaortic echo probe was placed on the bend relief, and this showed twisting and external compression of the outflow graft without evidence of an intraluminal thrombus. During dissection, there appeared to be a band of scar tissue causing external kinking of the outflow graft as well. After

release of the scar tissue, it was noted that the LVAD flows improved dramatically. Subsequent exploration of the bend relief showed a visible white thrombus compressing the outflow graft surface, which was removed. With exchange of the bend relief and 180-degree rotation of the outflow graft, the LVAD flows recovered to baseline.
