Peer-Reviewed Case Report

Cutting the Cord: A Case of Late Presenting Driveline Infection

Wake Forest University, School of Medicine, Winston-Salem, NC

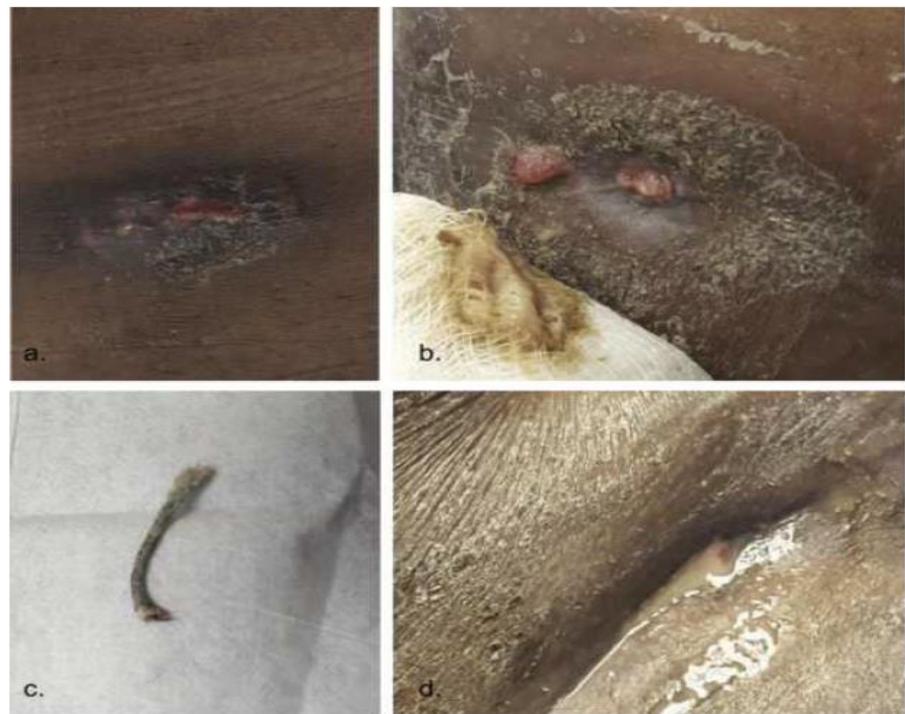
A 45-year-old man with ischemic cardiomyopathy underwent HeartMate II (Abbott) implantation as bridge-to-transplant intervention. His post-VAD course was complicated by recurrent gastrointestinal bleeding. He was noncompliant, desired non-traditional therapies and ultimately elected to discontinue anticoagulation, resulting in pump thrombosis. Echocardiogram revealed minimal myocardial recovery with persistent severe left ventricular dysfunction (ejection fraction ~ 10%). He was considered too high risk for VAD explantation. The VAD was inactivated, and inflow cannula and outflow grafts were left in situ. The driveline was severed and surgically buried. The incision was closed and healed completely. After 11 months, he presented with 3 weeks of local irritation and drainage at the old driveline exit site, which was exacerbated by his persistent digital manipulation of the area. Oral antibiotic therapy was initiated; however, the infection persisted. Local debridement revealed a wire from the driveline in the wound bed (Figure 1).

Figure 1. Evolution of the wound is displayed. (a) Initial encounter after driveline burial with scant purulent drainage is seen. (b) Purulent exit site infection approximately 11 months later. (c) Driveline remnant from wound. (d) Recurrent purulent infection just prior to VAD explant at 17 months post-implant.

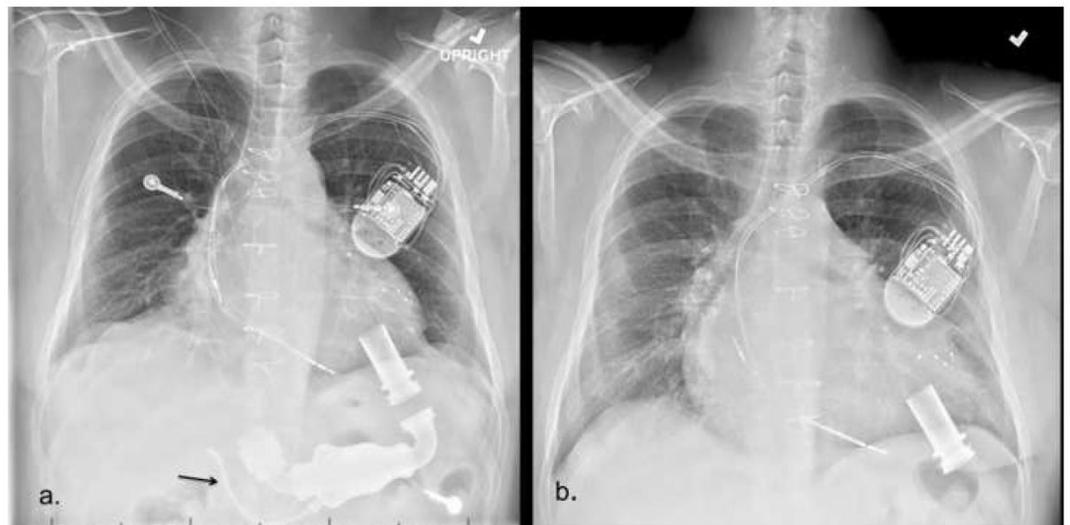
Figure 2. (a) Chest x-ray with Heartmate II driveline remnant (arrow). (b) Chest x-ray after Heartmate II explant.

During the procedure, the driveline exit site wound was found to be communicating with the VAD pocket. Copious amounts of purulent material was encountered in the VAD pocket and on the inflow and outflow grafts. Blood cultures were negative; and MSSA grew from intraoperative tissue and the explanted VAD. The patient is currently infection free, New York Heart Association Class III, 21 months post-VAD explant.

Operative wound cultures grew methicillin susceptible *Staphylococcus aureus* (MSSA). The patient was admitted twice in the subsequent six months for intravenous antibiotics and surgical debridement. Wound cultures repeatedly demonstrated MSSA. He declined palliative care and withdrawal of medical care; thus, due to persistent infection despite aggressive treatment, we recommended device removal for source control (Figure 2).
